Niagara Falls Radiation Sites

Niagara Falls Boulevard, Holy Trinity Cemetery

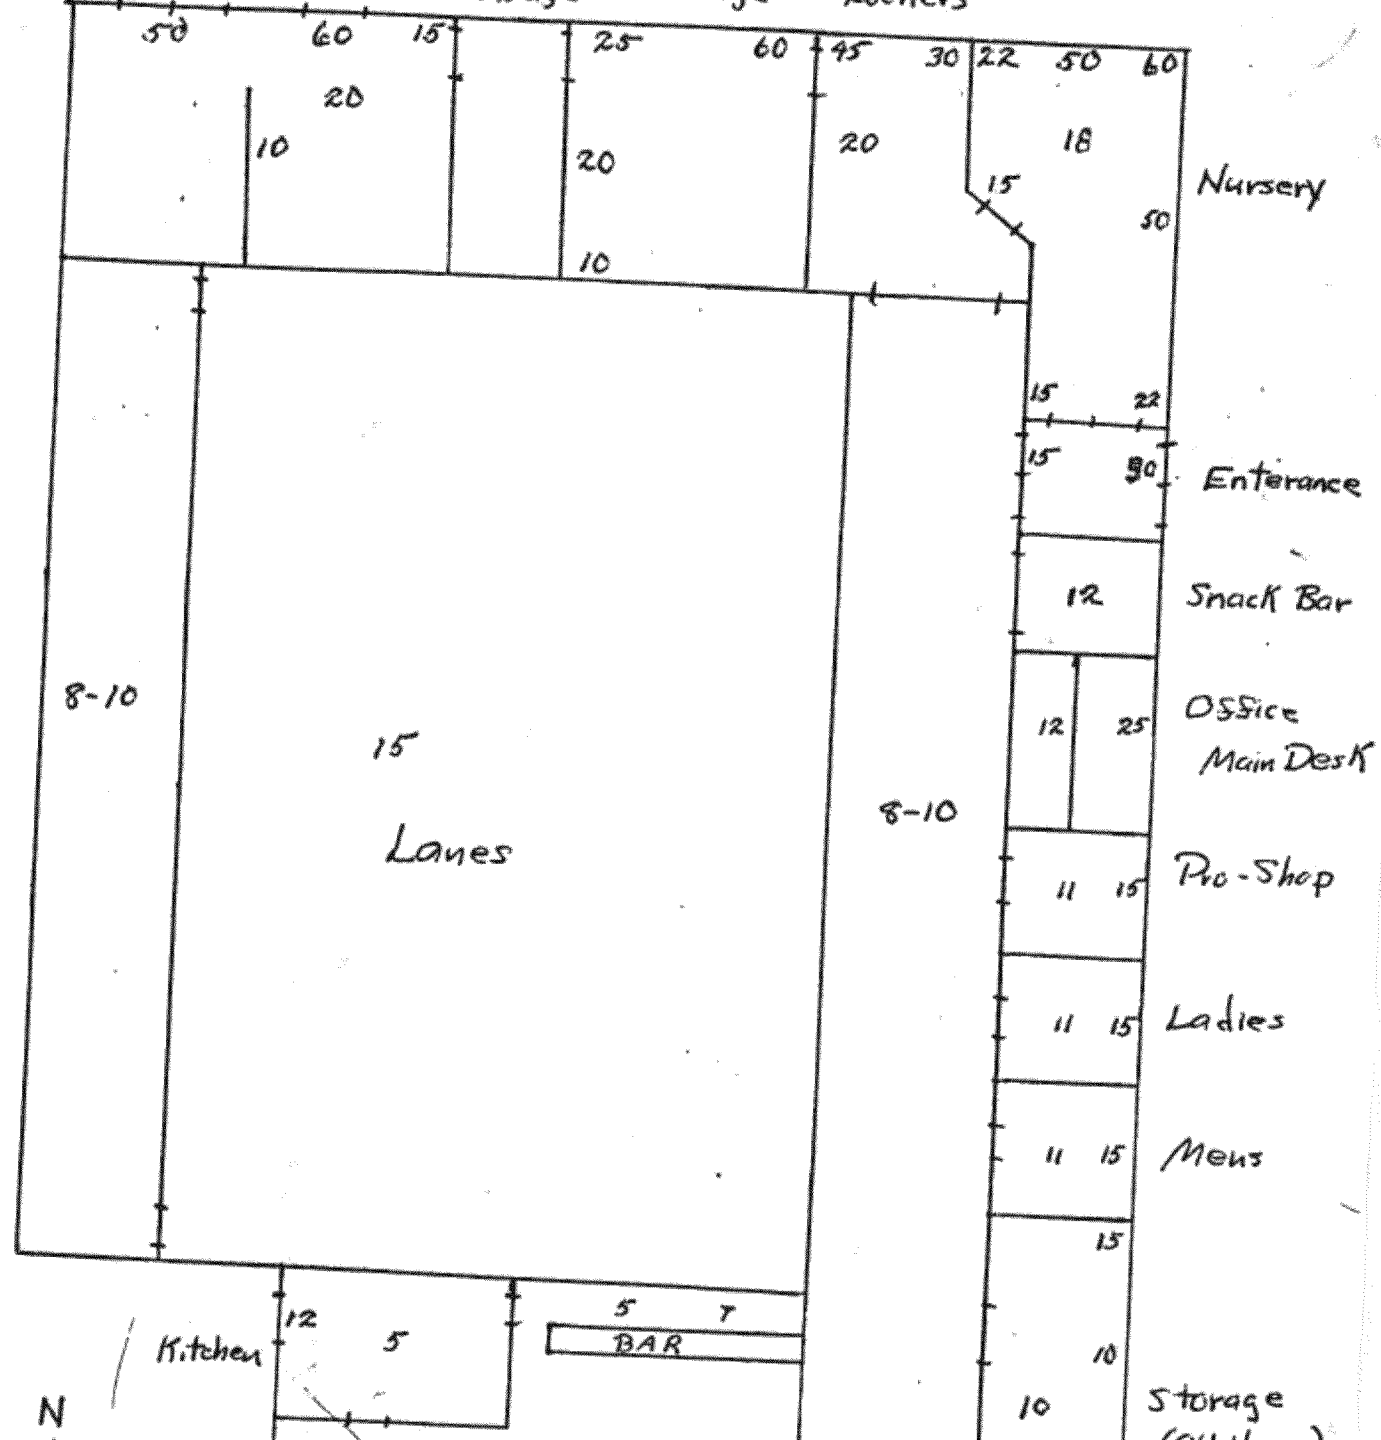
Niagara Falls Boulevard (NFB)

1979 NYSDOH radiological survey conclusions

- Present use of property does not constitute a hazard to workers or general public that would necessitate a remedial action
- Owners required to report change in ownership, maintain surface integrity of parking lot, collect and dispose of loose aggregate in the parking lot, contact DOH before performing intrusive work
- Owners felt that NY did not know what they were doing since one agency almost closed their doors and the other indicated no problem
- Note: 1980 DOH committee determined that the 15 areas identified in rad survey did not pose a significant health hazard. Future remedial action was not ruled out.

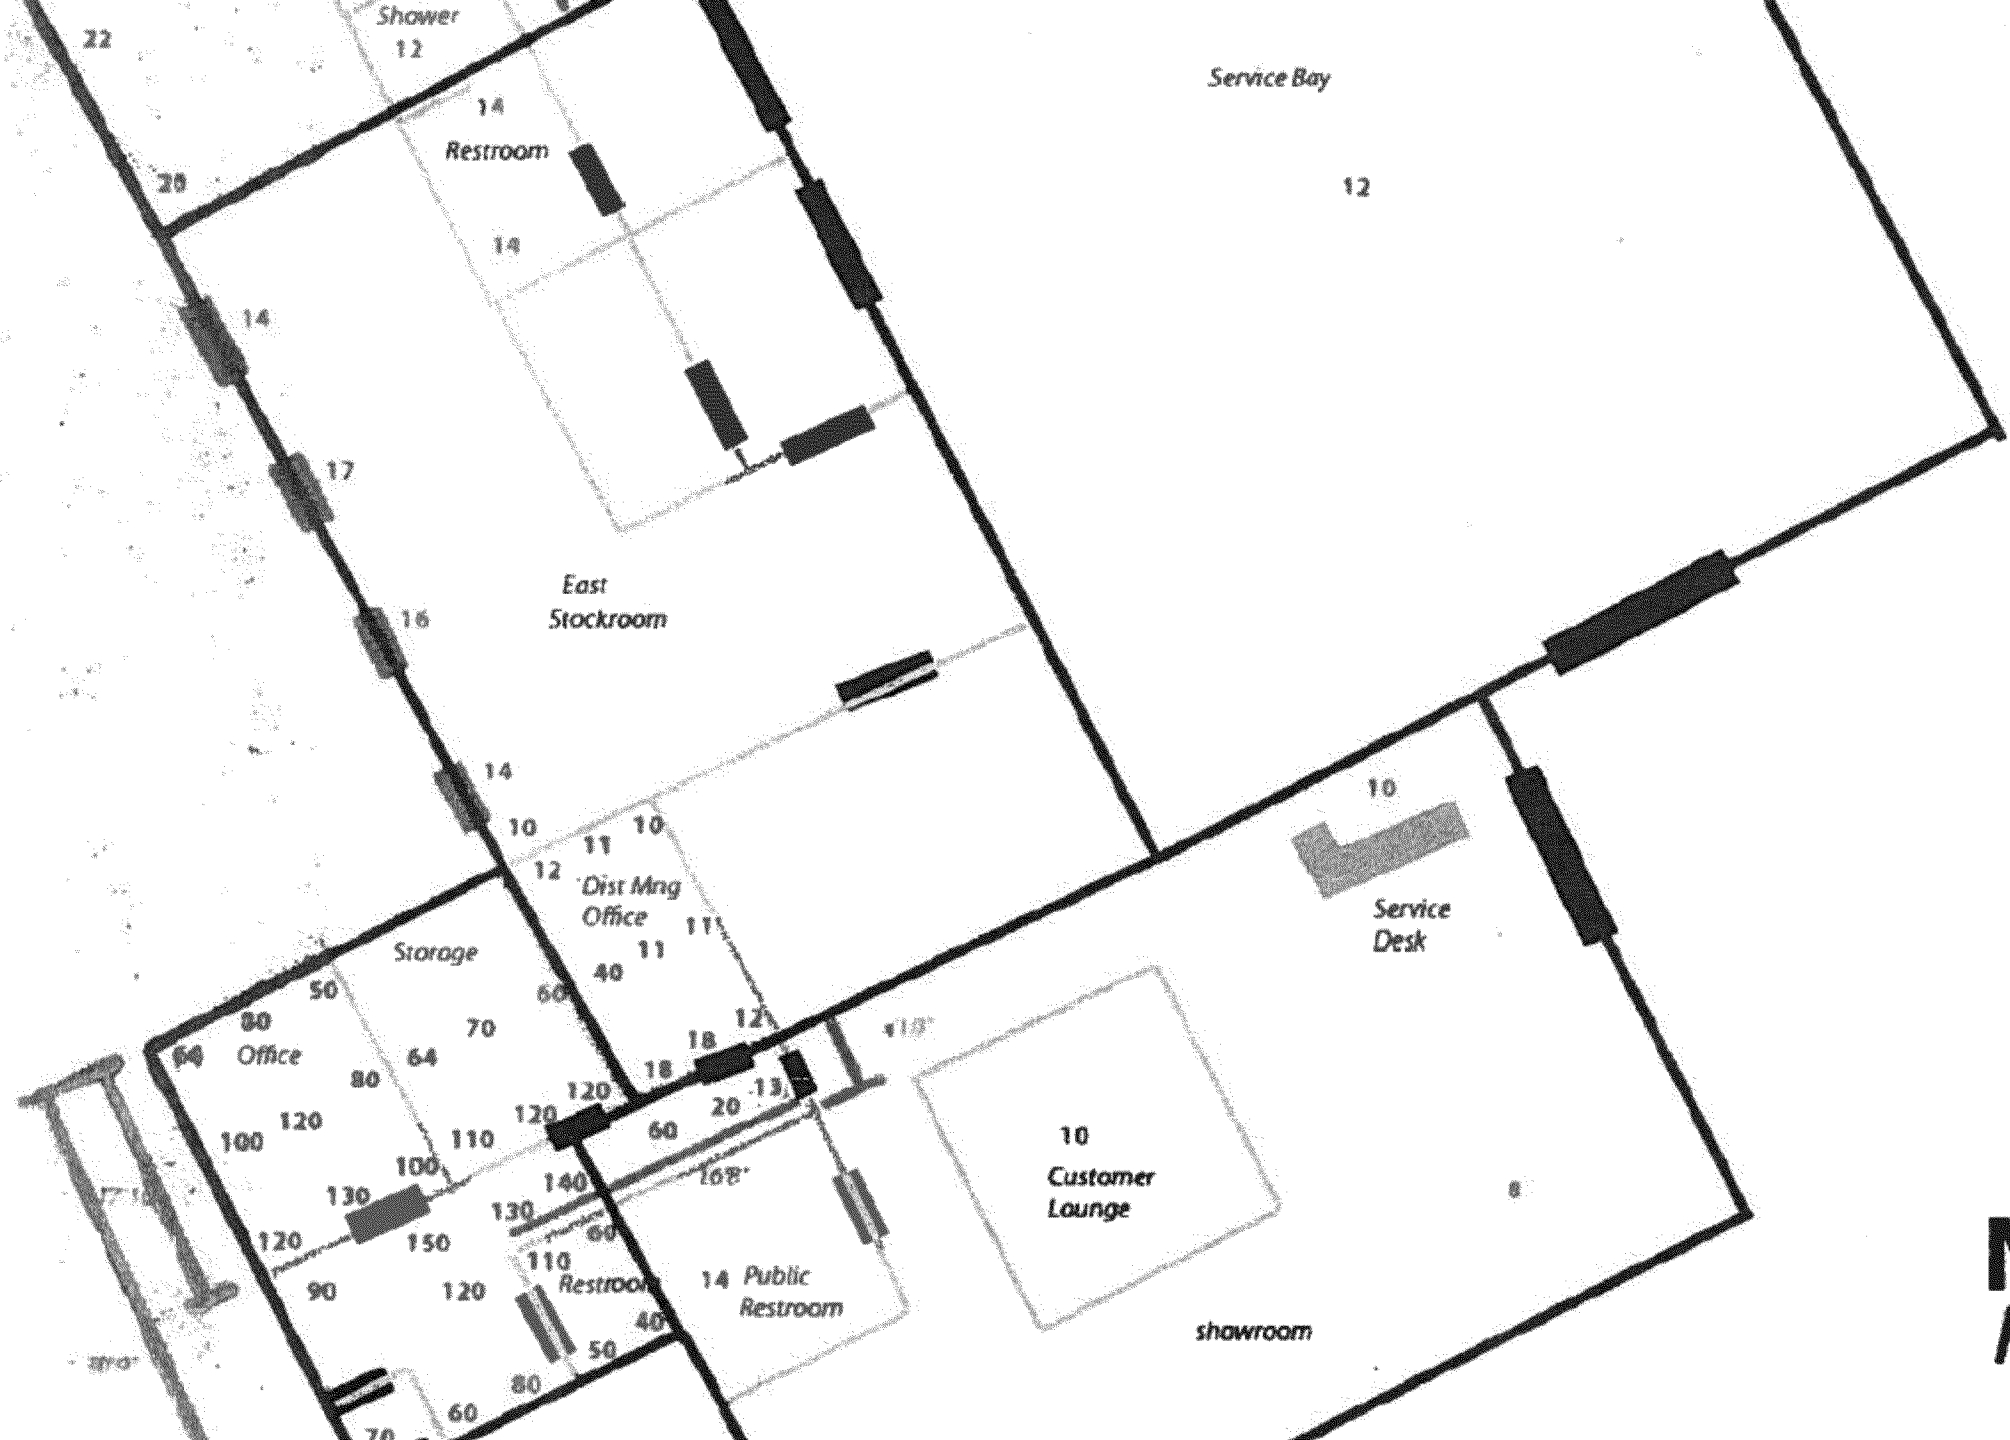
Niagara Falls Boulevard (NFB)

2006 NYSDOH radiological surveys

- Reiterated previous conclusions (not an immediate public health concern)
- Also indicated that this is not a permanent solution and that they were working with DEC to come up with one
- Highlights
 - Gamma levels in the 9540 NFB storage/office area are “low” and prolonged use could result in exposure > 100 mrem/yr (worse case = 300 mrem/yr).....”well below OSHA limit for workers (5,000 mrem/yr”. Recommend this area not be used as an office.
 - Radon measurements in both buildings < 4 pCi/L (also took 3-month measurements)
 - Relatively low gamma readings identified along certain property boundaries

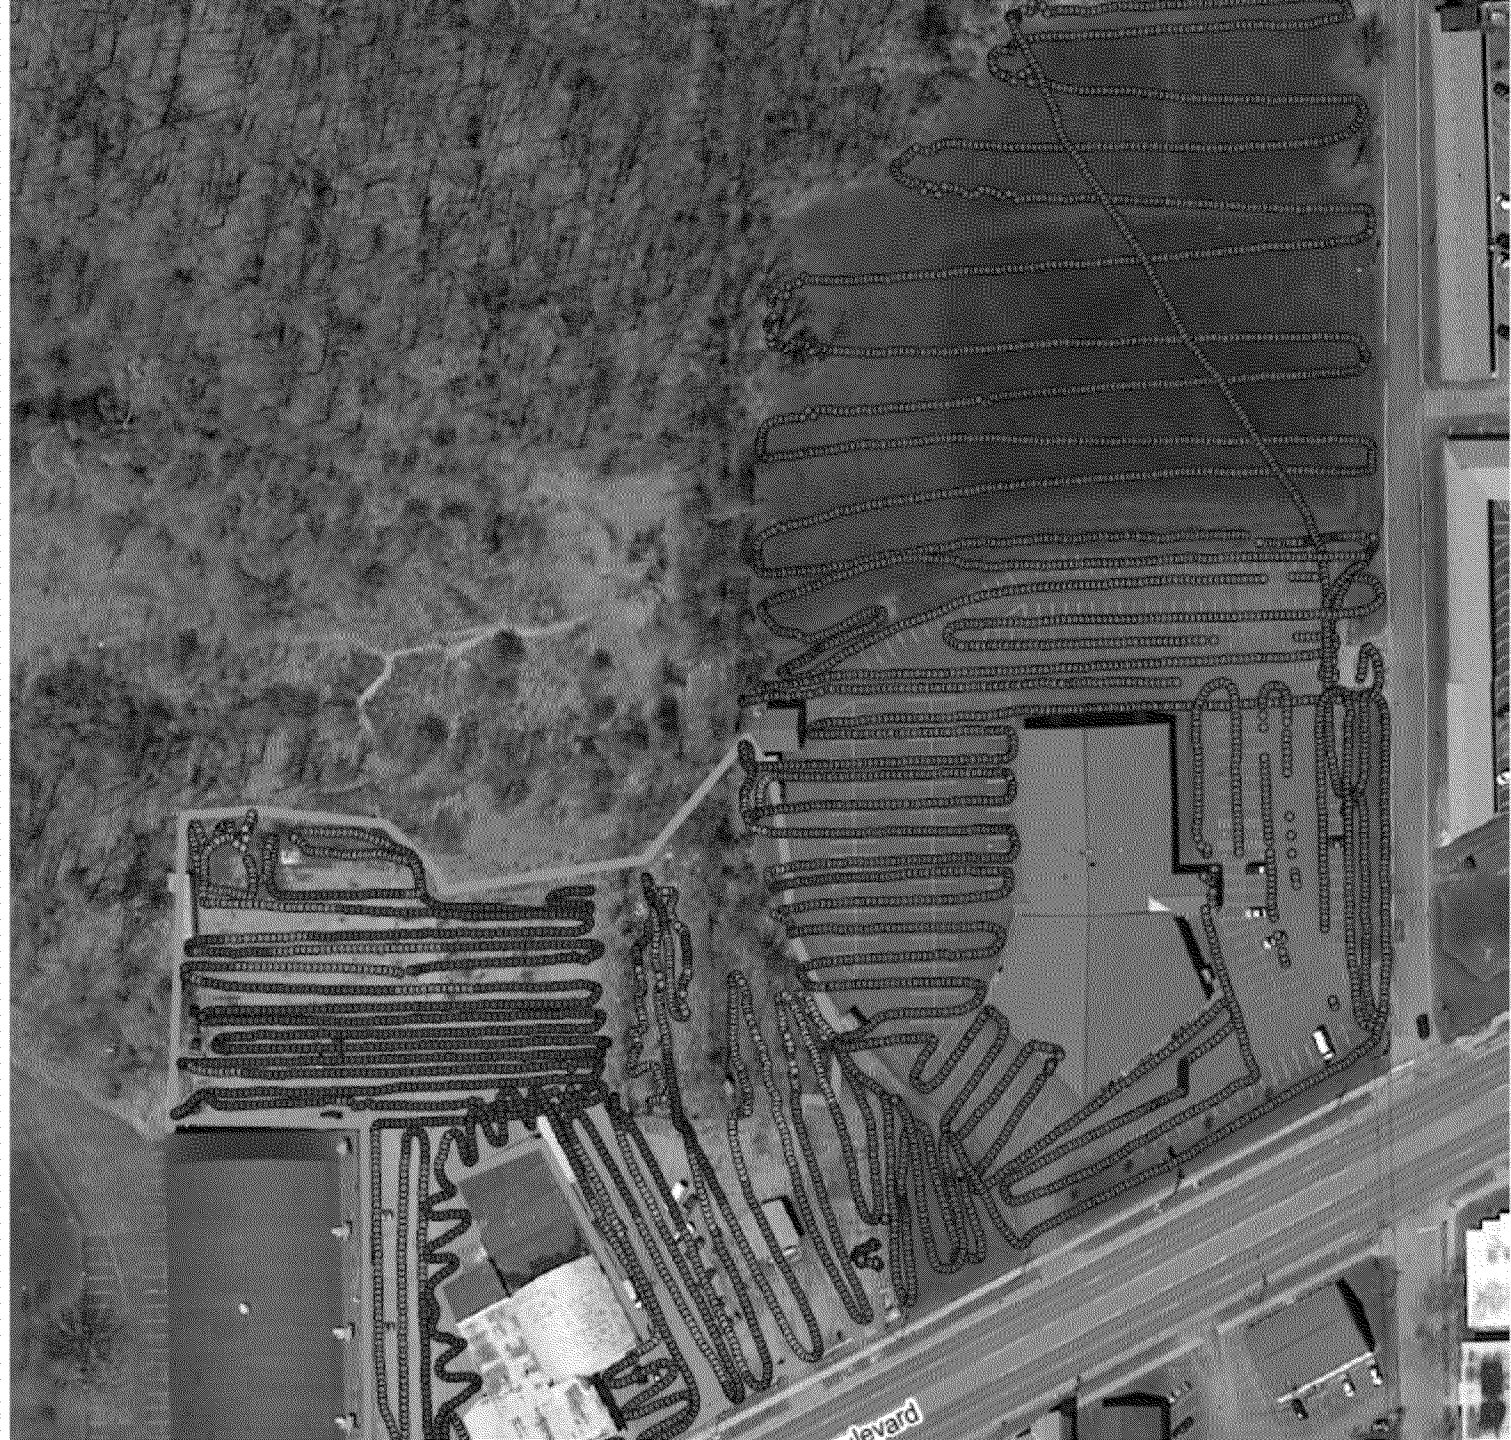
Niagara Falls Boulevard (NFB)

2013 - 2014 EPA Pre-remedial Site Investigation

- Surface measurements
- Soil/slag samples (including below slag)
 - Radioisotopes w/gamma spectroscopy
 - Gamma measurements with depth to 4 ft
- Radon and thoron measurements w/RAD7 radon detectors
- Highlights
 - Slag identified down to 0.5 ft. to 2 ft. depth
 - Ratios of individual isotopes were not consistent

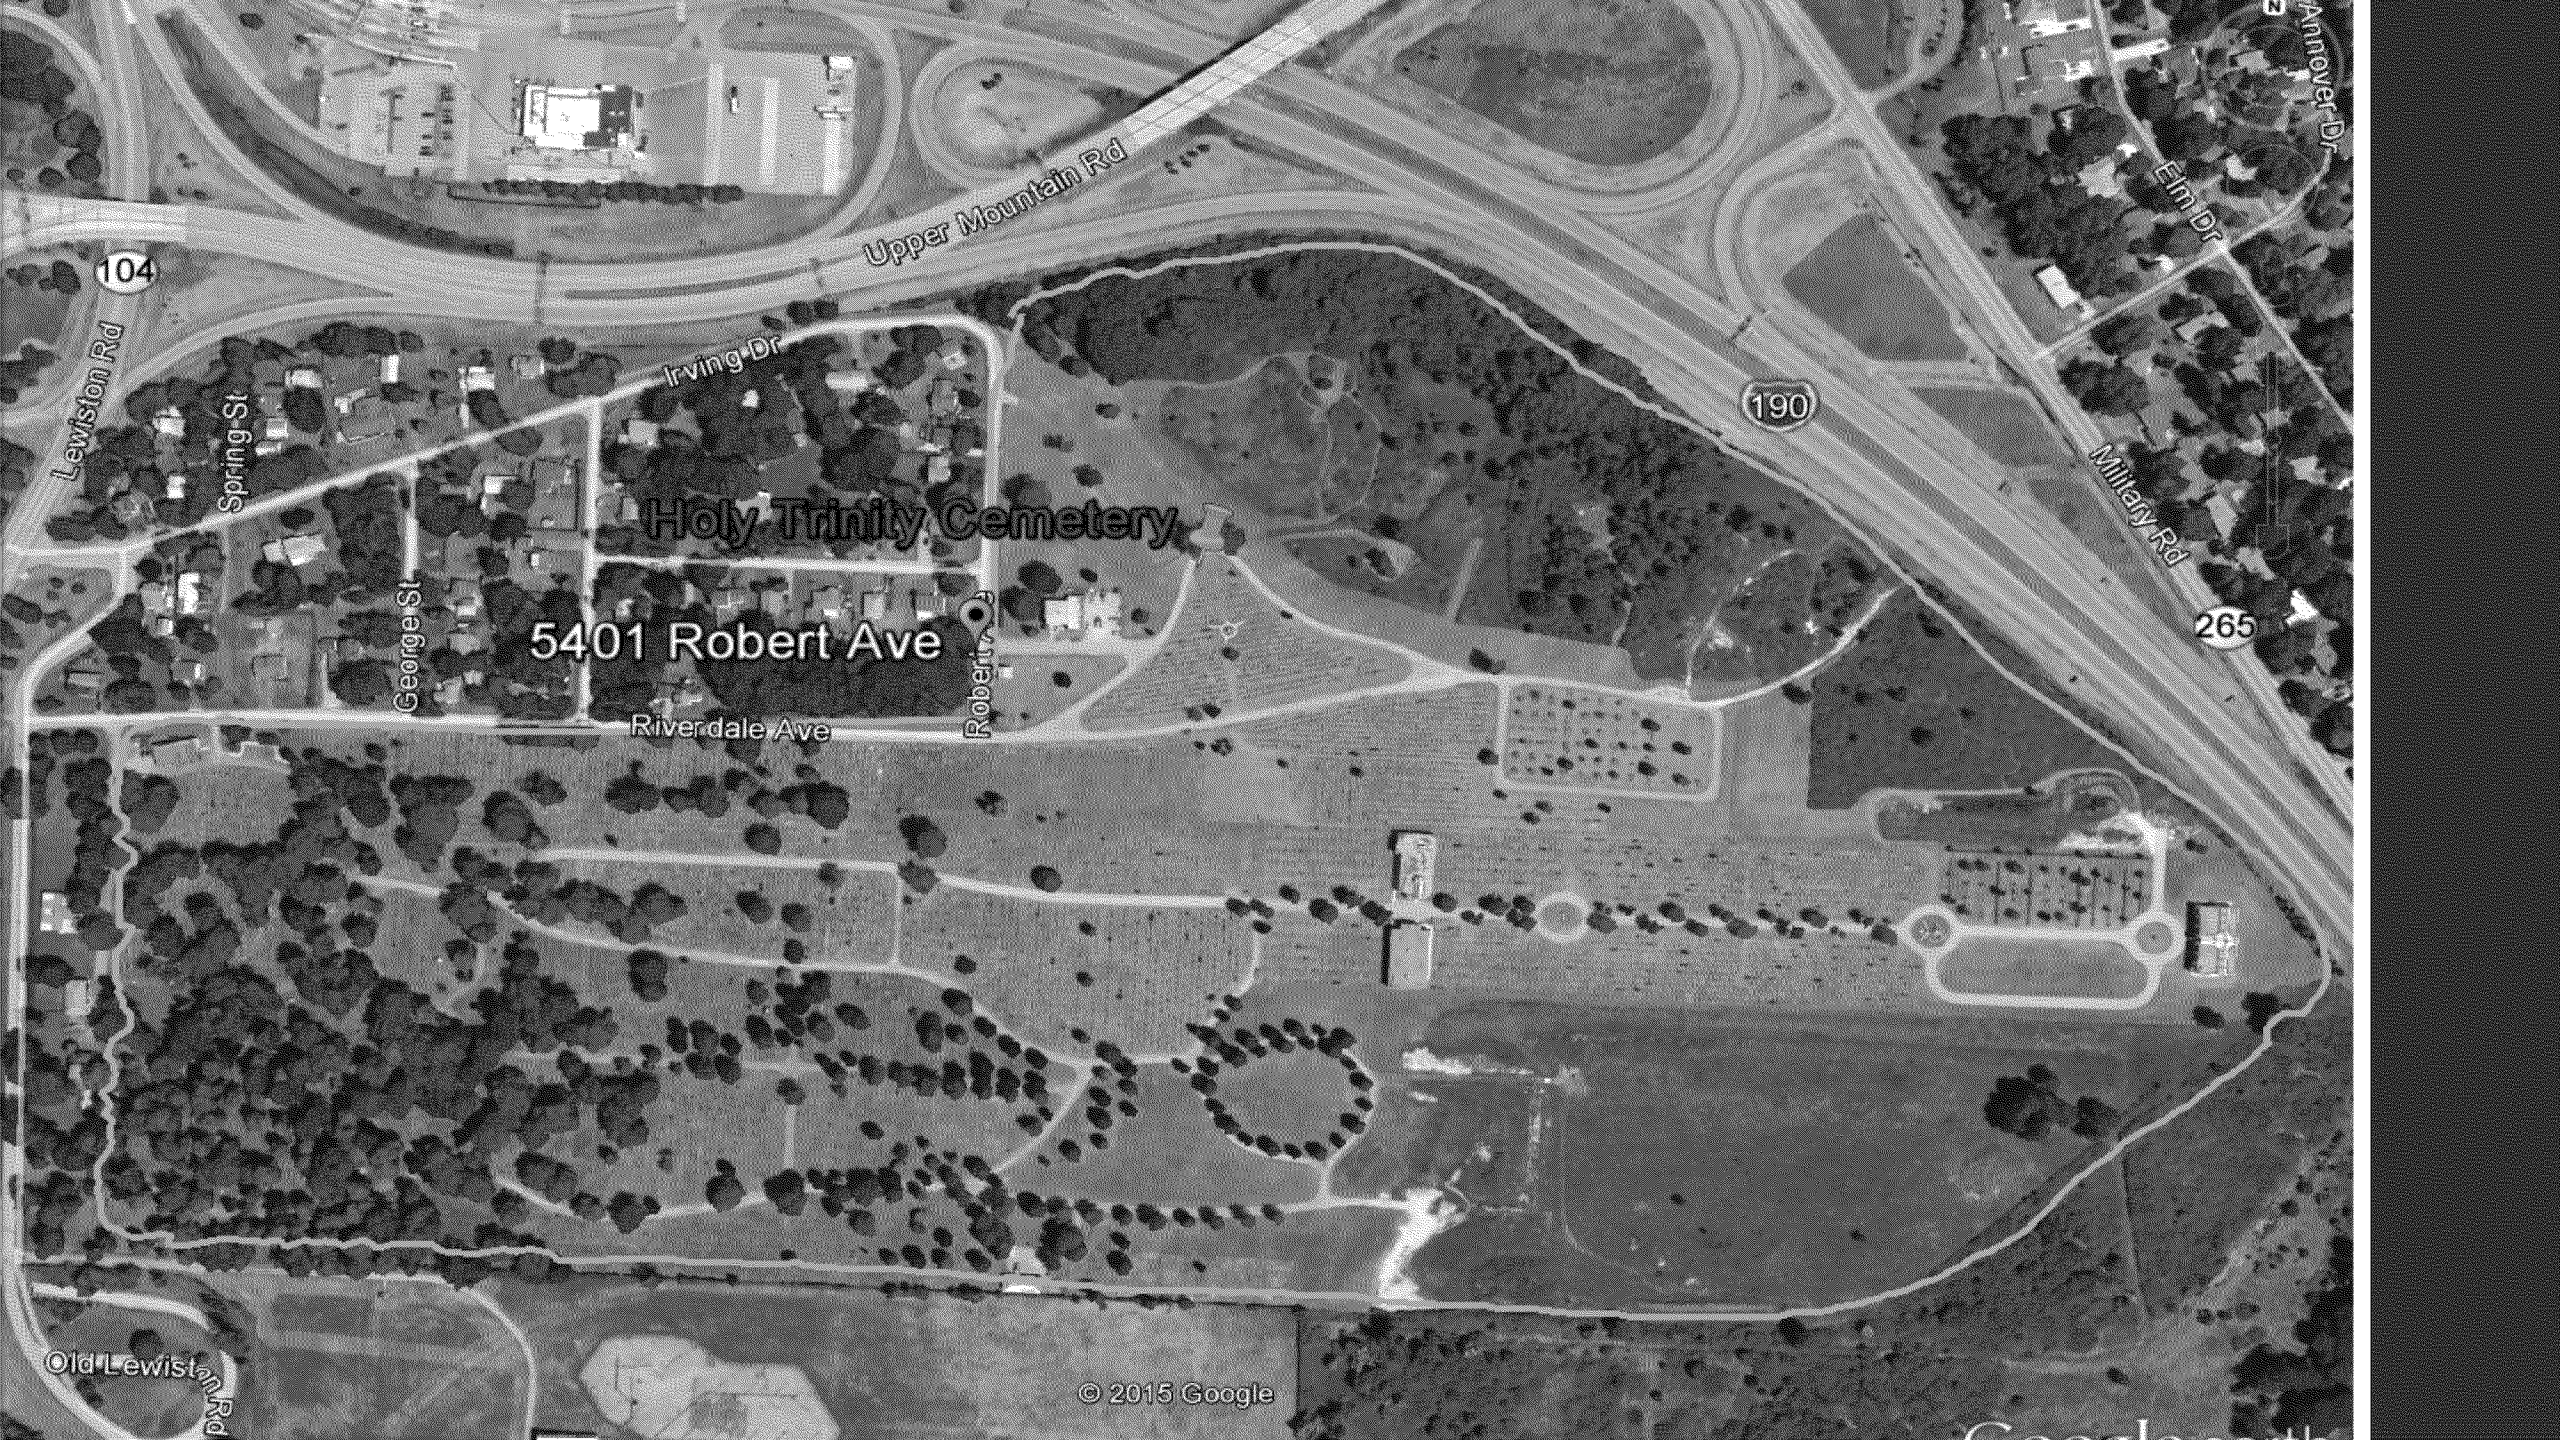
Holy Trinity Cemetery (HTC)

5401 Robert Avenue

- 31 acre property; area of concern 2.9 acres
- Includes a caretaker's house and maintenance garage
- Area of concern is an used portion of cemetery (no imminent plans of expansion into this area)
- Slag used as base for two never completed cemetery roadways (subsequently covered with soil)
